**Flood Control Project Maintenance  
Levee Inspections**

**Fall 2018 Levee Maintenance Deficiency Summary Report**

**Sacramento River Basin**

**Flood Control Project Maintenance  
Levee Inspections****LMA District Cover Sheet****Fall 2018 Levee Inspection Results****Reclamation District No. 0003 Grand Island**

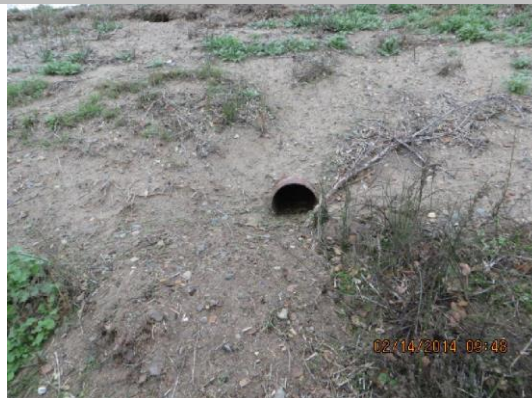
Photo 1 of 2 : UCIP\_FA\_2018\_41583\_55234.jpg

LM Start	0.06	Rating **	M	Issue No.	189
LM End	0.06	Issue Type +	En	Location *	
Category	Supplemental			GPS Latitude/Longitude	
				Start	End
Item	DWR UCIP Field Study			38.303892 °	38.303892 °
				-121.575309 °	-121.575309 °
DWR ID	22134				
Comment Code					
Inspector Comment					
FS_ID:41583 DS_ID:22134 EP_NO: N/A Repair Type: Non-Urgent Crossing Status: Found UCIP Comments: Pipe open on LS slope. Appears abandoned and if so should be done so properly. FIELD_STRUCT_DESC: *ABANDONED* 10-inch steel irrigation pipe through the levee, invert elevation 6.6 feet below the crown. 36-inch concrete standpipe visible 30 feet upstream from the crossing on the landside (LS) toe. Pipe open on both ends. [Additional Reference(s): DWR Levee Log, 1993. USACE Sacramento O&M Manual 104, February 1960, (RM 26.06)]. FS Date: 8/27/2014

Open pipe visible on LS slope.

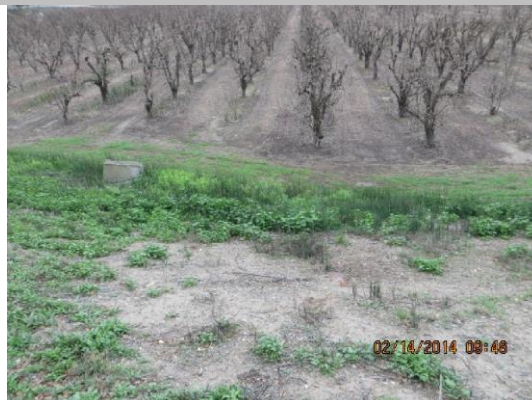
Photo 2 of 2 : UCIP\_FA\_2018\_41583\_55233.jpg

Concrete standpipe visibel on LS slope

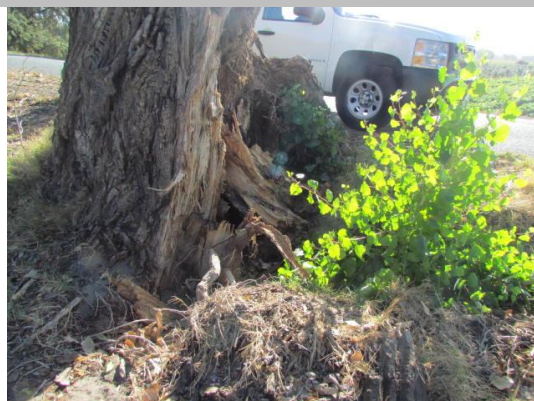
LM Start	<b>0.13</b>	Rating **	M	Issue No.	<b>2 (cont)</b>
LM End	<b>0.13</b>	Issue Type +	Ma	Location *	WS

Looking at a hole next to oak tree on waterward shoulder.(2015)

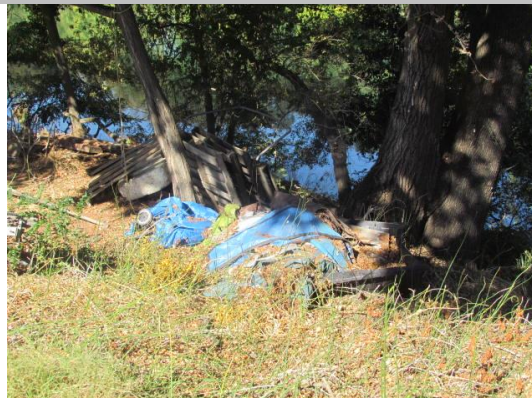
Photo 1 of 4 : FA\_2018\_RD0003\_24\_188\_20180925\_00086.jpg

Looking southwest at garbage on waterward berm. (Fall 2014)

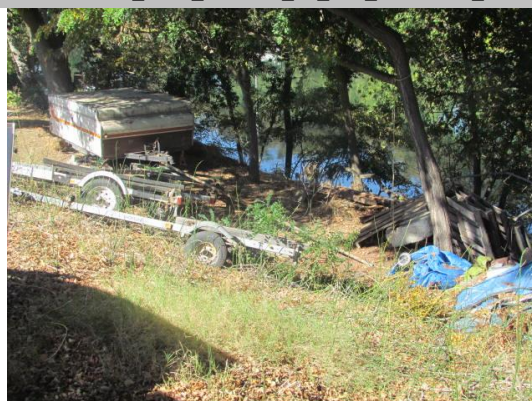
Photo 2 of 4 : FA\_2018\_RD0003\_24\_188\_20180925\_00087.jpg

Looking southwest at garbage and equipment on waterward berm. (Fall 2014)

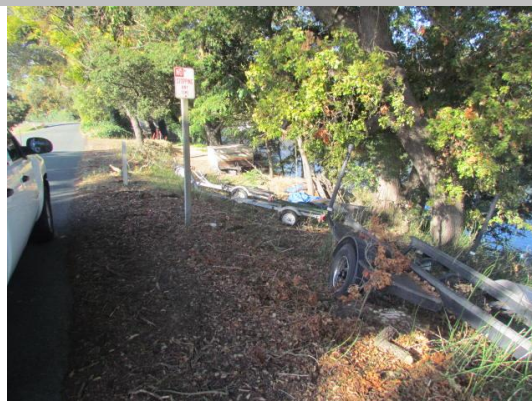
Photo 3 of 4 : FA\_2018\_RD0003\_24\_188\_20180925\_00088.jpg

Looking southwest at equipment and garbage stored on waterward slope and toe. (Spring 2014)

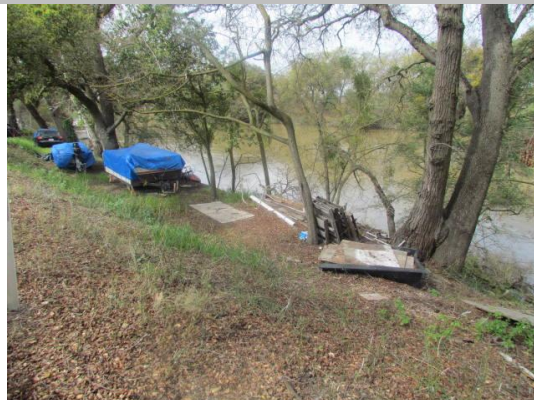
Photo 4 of 4 : FA\_2018\_RD0003\_24\_188\_20180925\_00089.jpg

LM Start	0.21	Rating **	M	Issue No.	188 (cont)	
LM End	0.21	Issue Type +	En	Location *	WS	
Category	Earthen Levee			GPS Latitude/Longitude		
				Start		End
Item	Encroachments			38.302625 °		38.302625 °
				-121.577683 °		-121.577683 °
DWR ID	DWR_RD0003_01_s_2012_188					
Comment Code						
GA : Garbage						
Inspector Comment						
Landowner has piled wooden boards and trash on waterside berm.

Looking southwest at trash on waterside berm. (Spring 2014)

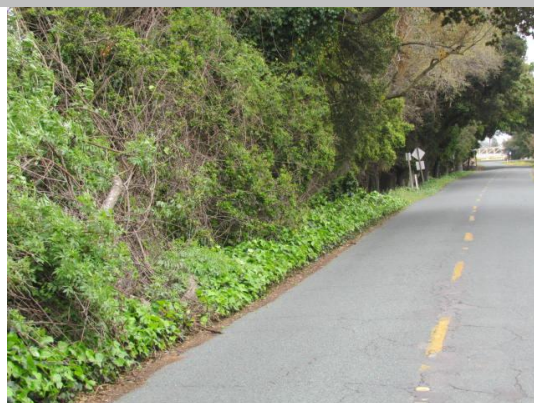
Photo 1 of 2 : FA\_2018\_RD0003\_24\_6\_20180925\_00004.jpg

LM Start	0.22	Rating **	U	Issue No.	6
LM End	0.33	Issue Type +	En	Location *	WS
Category	Earthen Levee			GPS Latitude/Longitude	
				Start	End
Item	Vegetation			38.302530 °	38.301424 °
				-121.577848 °	-121.579113 °
DWR ID	DWR_RD0003_01_s_2012_6				
Comment Code					
V6 : Landscaping					
Inspector Comment					
Dense landscaping on waterward shoulder and slope.

Looking northeast at dense landscaping on waterward shoulder.

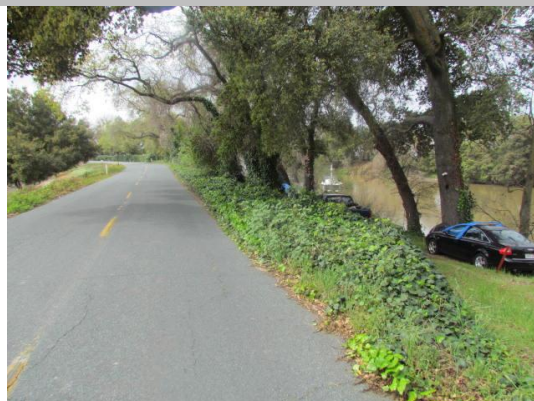
Photo 2 of 2 : FA\_2018\_RD0003\_24\_6\_20180925\_00005.jpg

Looking southwest at landscaping on waterside shoulder and slope. (2015)

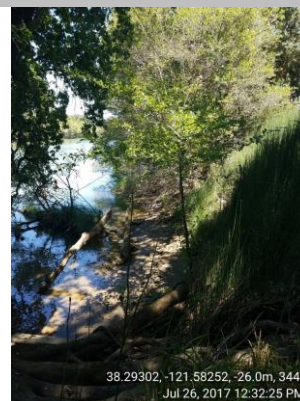
Photo 1 of 3 : LEVAL\_FA\_2018\_275\_2396.jpg

LM Start	0.91	Rating **	A/W	Issue No.	53
LM End	0.97	Issue Type +	Ma	Location *	
Category	Supplemental			GPS Latitude/Longitude	
				Start	End
Item	2017 Storm Damage			38.293381 °	38.292617 °
				-121.582450 °	-121.582675 °
DWR ID	DWR_RD0003_01_s_2018_53				
Comment Code					
Inspector Comment					
Levee Evaluation Comments					
Description: District station 48+20 to 51+06, Sec. 07, T. 5 N. R. 4 E., M.D.M. An erosion site exists along approximately 286 linear feet of the water side slope of Steamboat Slough (Unit 1). The erosion begins approximately 1/2 of the way down the slope from the crown to the waterside toe. Erosion is undercutting existing trees.					
Site ID No: 275					
Site Designation: LMA-101					
Repair Type: Erosion					
Rating: Serious					
Field Date: 7/26/2017					
Notes:

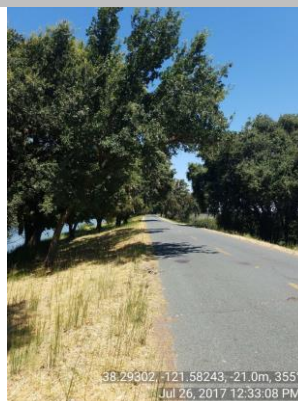
Photo 3 of 3 : LEVAL\_FA\_2018\_275\_2399.jpg

LM Start	0.91	Rating **	A/W	Issue No.	53 (cont)	
LM End	0.97	Issue Type +	Ma	Location *		
Category	Supplemental			GPS Latitude/Longitude		
				Start	End	
Item	2017 Storm Damage			38.293381 °	38.292617 °	
				-121.582450 °	-121.582675 °	
DWR ID	DWR_RD0003_01_s_2018_53					
Comment Code						
Inspector Comment						
Levee Evaluation Comments						
Description:District station 48+20 to 51+06, Sec. 07, T. 5 N. R. 4 E., M.D.M. An erosion site exists along approximately 286 linear feet of the water side slope of Steamboat Slough (Unit 1). The erosion begins approximately 1/2 ofthe way down the slope from the crown to the waterside toe. Erosion is undercutting existing trees.						
Site ID No:275						
Site Designation:LMA-101						
Repair Type: Erosion						
Rating:Serious						
Field Date:7/26/2017						
Notes:

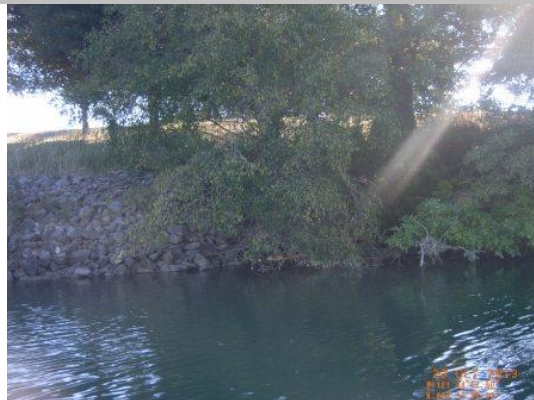
Photo 1 of 1 : FA\_2018\_RD0003\_24\_49\_20181023\_00151.jpg

2017 Site ID: STM 25.0 L  
Status: Critical  
2018: Deep erosion into levee toe. Roots are exposed. I would consider this critical.  
2017 Field Notes: Upgraded to critical. Site has eroded to near vertical at upstream end.  
Site History: 1997 - Erosion of sandy levee on top left bank. Site is downstream of a rock section. Large riparian trees on the bank. 1999 - Upstream half of the reach repaired with rock, except for a 30 ft reach at the upstream end. 2001 - Rock repair on the upstream and downstream ends; no revetment at the trees. 2002 - Rock repair is starting to slide off the geotextile at the upstream end. 2005 - One new small tree has fallen. 2006 - 50 ft pocket at the downstream end and at the upstream end with new rock in between. 2007 - Upstream end has been repaired. 2008 - Area closed sign on bank. Newly fallen trees at both ends and pop outs along the bank. 2010 - Site extended downstream. 2011 - New erosion at the toe. More trees popouts. 2013 - Short vertical sections observed at the downstream end. 2015 - Significant new erosion, large oak tree on verge of popping out. 2016 - Sites 24.8 and 25 were combined.

USACE 2013 Photo #1

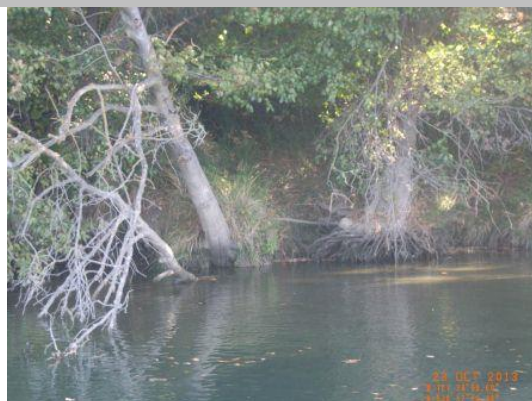
Photo 2 of 2 : FA\_2018\_RD0003\_24\_56\_20181023\_00167.jpg

LM Start	1.03	Rating **	U	Issue No.	56 (cont)
LM End	1.18	Issue Type +	Ma	Location *	WS
Category	Supplemental			GPS Latitude/Longitude	
				Start	End
Item	2017 USACE Erosion Survey, DRAFT			38.291695 °	38.289575 °
				-121.582993 °	-121.583092 °
DWR ID	DWR_RD0003_01_f _ 2018_56				
Comment Code					
Inspector Comment					
2017 Site ID: STM 24.8 L					
Status: Eroding					
2018: Pockets of erosion that are deep into the levee toe that I would consider critical (Djulian).					
2017 Field Notes: New erosion at toe.					
Site History: 2008 - Area closed sign on bank. Newly fallen trees at both ends and pop outs along the bank. 2010 - Site extended downstream. 2011 - New erosion at the toe. More trees popouts.					
2013 - Short vertical sections observed at the downstream end.

USACE 2013 Photo #2

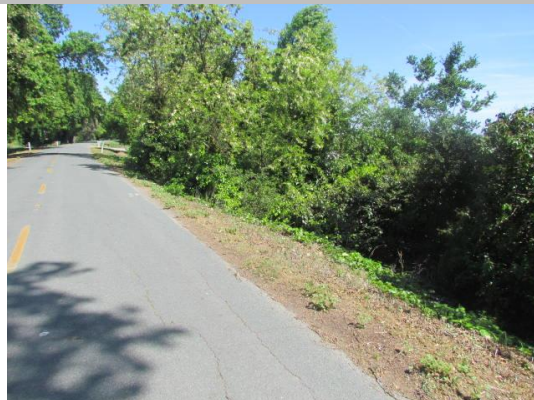
Photo 1 of 2 : FA\_2018\_RD0003\_24\_12\_20180925\_00012.jpg

LM Start	1.07	Rating **	U	Issue No.	12
LM End	1.08	Issue Type +	En	Location *	LS
Category	Earthen Levee			GPS Latitude/Longitude	
				Start	End
Item	Vegetation			38.291055 °	38.290898 °
				-121.582765 °	-121.582777 °
DWR ID	DWR_RD0003_01_s_2012_12				
Comment Code					
V6 : Landscaping					
Inspector Comment

Looking northeast at dense landscape on landward slope. (Spring 2013)

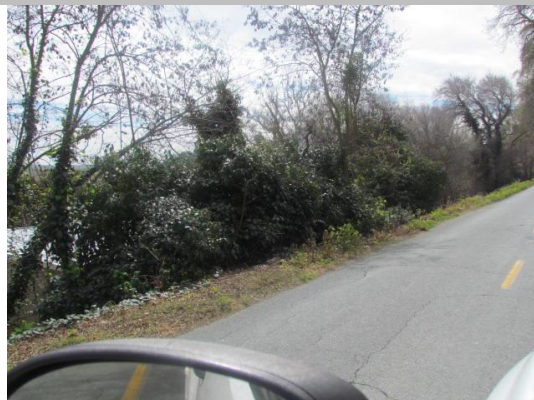
Photo 2 of 2 : FA\_2018\_RD0003\_24\_12\_20180925\_00013.jpg

Looking southeast at landscaping on landside slope.

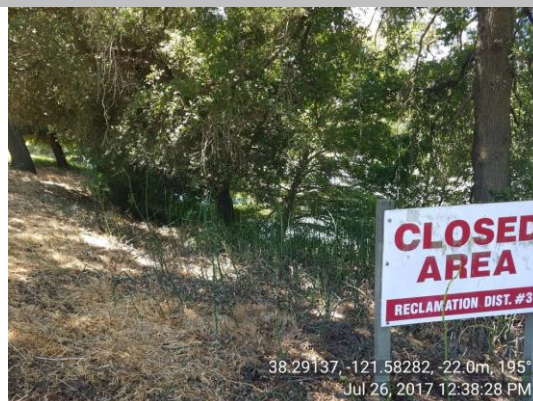
Photo 1 of 3 : FA\_2018\_RD0003\_24\_60\_20180925\_00044.jpg

LM Start	1.09	Rating **	A/W	Issue No.	60
LM End	1.10	Issue Type +	Ma	Location *	
Category	Supplemental			GPS Latitude/Longitude	
				Start	End
Item	2017 Storm Damage			38.290819 °	38.290706 °
				-121.582942 °	-121.582939 °
DWR ID	DWR_RD0003_01_f_2017_60				
Comment Code					
Inspector Comment					
Levee Evaluation Comments					
Description: District station 57+57 to 57+98, Sec. 18, 1. 5 N. R. 4 E., M.D.M. An erosion site exists along approximately 41 linear feet of the water side slope of Steamboat Slough (Unit 1). The erosion commences approximately 1/2 of the way down the slope from the crown to the waterside toe.					
Site ID No: 276					
Site Designation: LMA-102					
Repair Type: Erosion					
Rating: Area of Concern					
Field Date: 7/26/2017					
Notes:

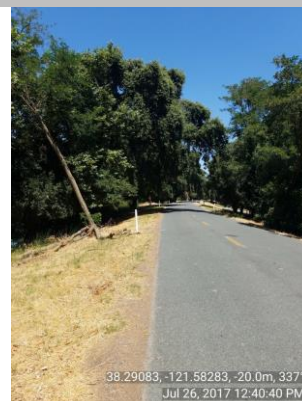
Photo 3 of 3 : FA\_2018\_RD0003\_24\_60\_20180925\_00046.jpg

LM Start	1.09	Rating **	A/W	Issue No.	60 (cont)	
LM End	1.10	Issue Type +	Ma	Location *		
Category	Supplemental			GPS Latitude/Longitude		
				Start	End	
Item	2017 Storm Damage			38.290819 °	38.290706 °	
				-121.582942 °	-121.582939 °	
DWR ID	DWR_RD0003_01_f_2017_60					
Comment Code						
Inspector Comment						
Levee Evaluation Comments						
Description: District station 57+57 to 57+98, Sec. 18, 1. 5 N. R. 4 E., M.D.M. An erosion site exists along approximately 41 linear feet of the water side slope of Steamboat Slough (Unit 1). The erosion commences approximately 1/2 of the way down the slope from the crown to the waterside toe.						
Site ID No: 276						
Site Designation: LMA-102						
Repair Type: Erosion						
Rating: Area of Concern						
Field Date: 7/26/2017						
Notes:

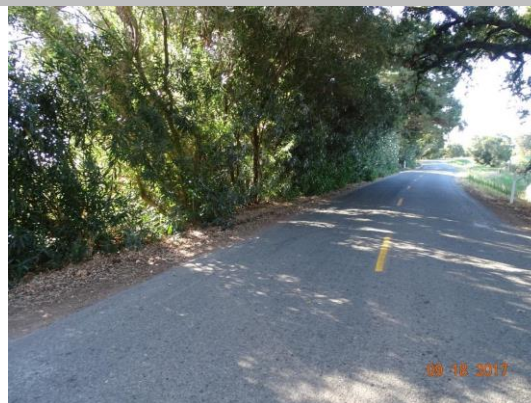
Photo 1 of 2 : FA\_2018\_RD0003\_24\_21\_20180925\_00022.jpg

LM Start	1.21	Rating **	U	Issue No.	21
LM End	1.26	Issue Type +	En	Location *	LS
Category	Earthen Levee			GPS Latitude/Longitude	
				Start	End
Item	Vegetation			38.289130°	38.288327°
				-121.582800°	-121.582822°
DWR ID	DWR_RD0003_01_s_2013_21				
Comment Code					
V6 : Landscaping					
Inspector Comment					
Landscaping has been in place for several years.

Looking south at landside slope.

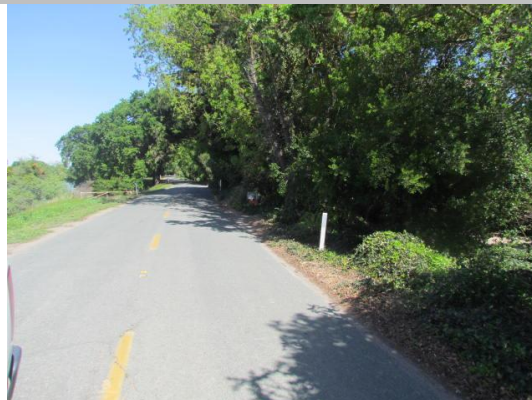
Photo 2 of 2 : FA\_2018\_RD0003\_24\_21\_20180925\_00023.jpg

LM Start	1.21	Rating **	U	Issue No.	21 (cont)	
LM End	1.26	Issue Type +	En	Location *	LS	
Category	Earthen Levee			GPS Latitude/Longitude		
				Start	End	
Item	Vegetation			38.289130°	38.288327°	
				-121.582800°	-121.582822°	
DWR ID	DWR_RD0003_01_s_2013_21					
Comment Code						
V6 : Landscaping						
Inspector Comment						
Landscaping has been in place for several years.

Looking north at dense landscaping on landward shoulder and slope.(Spring 2017)

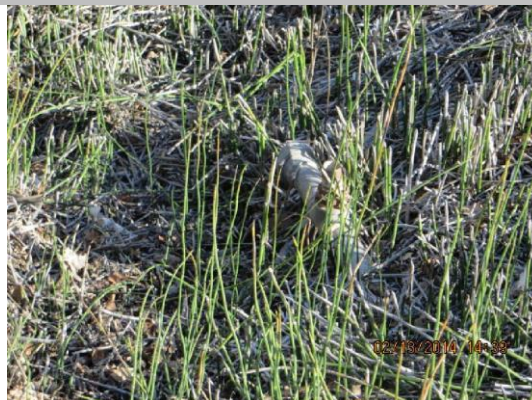
Photo 3 of 3 : UCIP\_FA\_2018\_31287\_57296.jpg

LM Start	1.32	Rating **	M	Issue No.	190 (cont)	
LM End	1.32	Issue Type +	En	Location *		
Category	Supplemental			GPS Latitude/Longitude		
				Start	End	
Item	DWR UCIP Field Study			38.287515 °	38.287515 °	
				-121.582925 °	-121.582925 °	
DWR ID	24838					
Comment Code						
Inspector Comment						
FS_ID:31287 DS_ID:24838 EP_NO: N/A Repair Type: Non-Urgent Crossing Status: Found UCIP Comments: Appears abandoned and if so should be done so properly. FIELD_STRUCT_DESC: *ABANDONED* 2.5-inch galvanized iron irrigation pipe through the levee, 4 feet below the crown. 1.25-inch galvanized iron electrical conduit at the same location. FS Date: 2/13/2014

Pipe visible just off LS shoulder in vegetation.

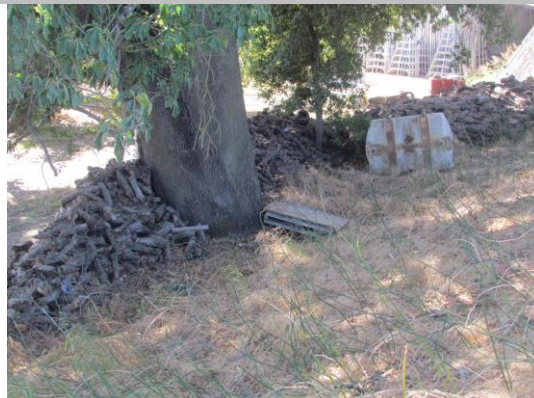
Photo 1 of 1 : FA\_2018\_RD0003\_24\_69\_20180925\_00053.jpg

LM Start	1.38	Rating **	M	Issue No.	69
LM End	1.38	Issue Type +	En	Location *	LS
Category	Earthen Levee			GPS Latitude/Longitude	
				Start	End
Item	Encroachments			38.286689 °	38.286689 °
				-121.583500 °	-121.583500 °
DWR ID	DWR_RD0003_01_s_2016_69				
Comment Code					
FW : Firewood					
Inspector Comment					
Landowner stockpiling firewood at landward toe.

Looking southeast at firewood stockpiled at landward toe.

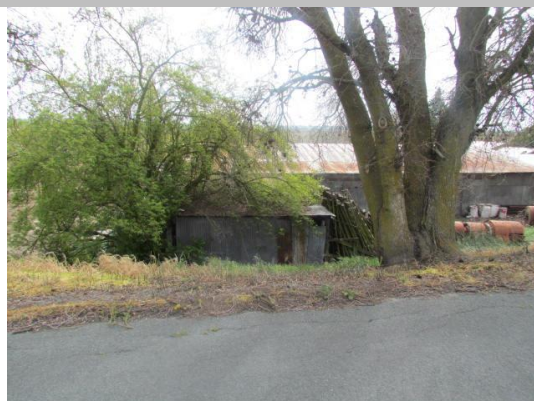
Photo 1 of 3 : FA\_2018\_RD0003\_24\_33\_20180925\_00026.jpg

LM Start	1.39	Rating **	U	Issue No.	33
LM End	1.43	Issue Type +	En	Location *	LS
Category	Earthen Levee			GPS Latitude/Longitude	
				Start	End
Item	Encroachments			38.286623 °	38.286225 °
				-121.583586 °	-121.584078 °
DWR ID	DWR_RD0003_01_s_2012_33				
Comment Code					
EQ : Equipment					
Inspector Comment					
Equipment and large fallen tree on landward toe.

Looking east at tool shed and equipment on landside toe.

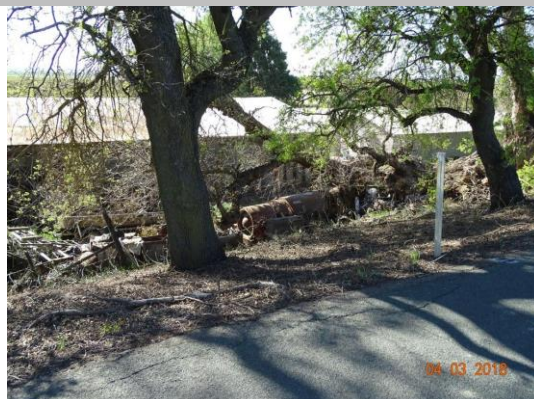
Photo 2 of 3 : FA\_2018\_RD0003\_24\_33\_20180925\_00027.jpg

Equipment and fallen tree on landside toe.

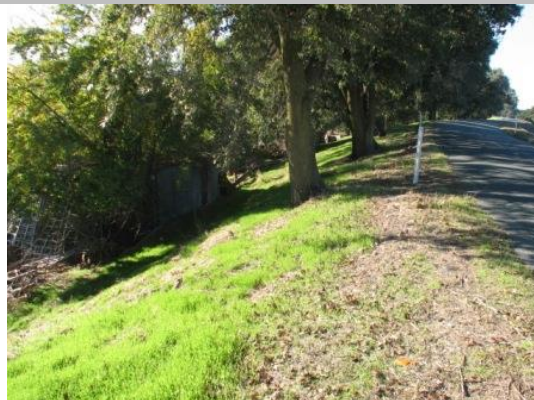
Photo 3 of 3 : FA\_2018\_RD0003\_24\_33\_20180925\_00028.jpg

LM Start	1.39	Rating **	U	Issue No.	33 (cont)	
LM End	1.43	Issue Type +	En	Location *	LS	
Category	Earthen Levee			GPS Latitude/Longitude		
				Start	End	
Item	Encroachments			38.286623 °	38.286225 °	
				-121.583586 °	-121.584078 °	
DWR ID	DWR_RD0003_01_s_2012_33					
Comment Code						
EQ : Equipment						
Inspector Comment						
Equipment and large fallen tree on landward toe.

Equipment within 10' of levee toe obstructs access and visibility.

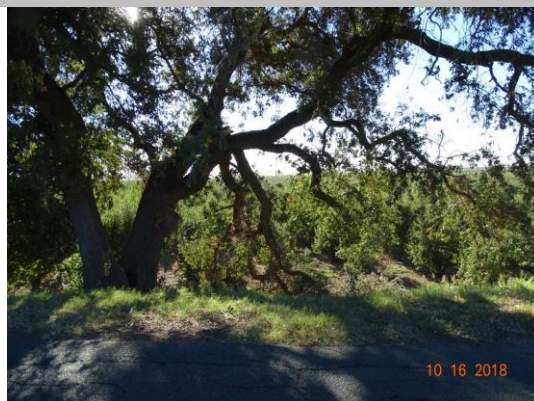
Photo 1 of 1 : FA\_2018\_RD0003\_24\_64\_20181017\_00160.jpg

LM Start	1.46	Rating **	M	Issue No.	64
LM End	1.46	Issue Type +	Ma	Location *	WS
Category	Earthen Levee			GPS Latitude/Longitude	
				Start	End
Item	Encroachments			38.285978 °	38.285978 °
				-121.584580 °	-121.584580 °
DWR ID	DWR_RD0003_01_f_2018_64				
Comment Code					
TR : Tree or limb					
Inspector Comment					
Fallen branch should be removed.

View of fallen tree limb on land side (October 2018).

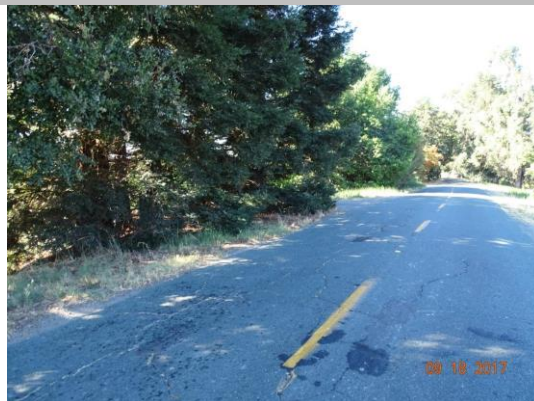
Photo 1 of 2 : FA\_2018\_RD0003\_24\_15\_20180925\_00014.jpg

LM Start	1.59	Rating **	U	Issue No.	15
LM End	1.59	Issue Type +	En	Location *	LS
Category	Earthen Levee			GPS Latitude/Longitude	
				Start	End
Item	Vegetation			38.284777 °	38.284777 °
				-121.586340 °	-121.586340 °
DWR ID	DWR_RD0003_01_f_2018_15				
Comment Code					
V6 : Landscaping					
Inspector Comment					
Large redwood trees on landward shoulder.

Looking southwest at landside slope.

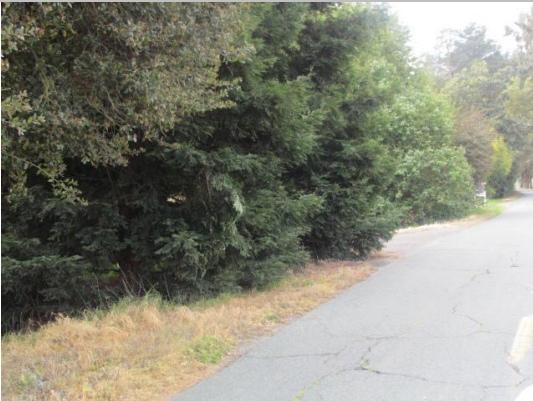
Photo 2 of 2 : FA\_2018\_RD0003\_24\_15\_20180925\_00015.jpg

Looking southeast at dense trees on landside shoulder and slope.  
(updated Spring 2012)

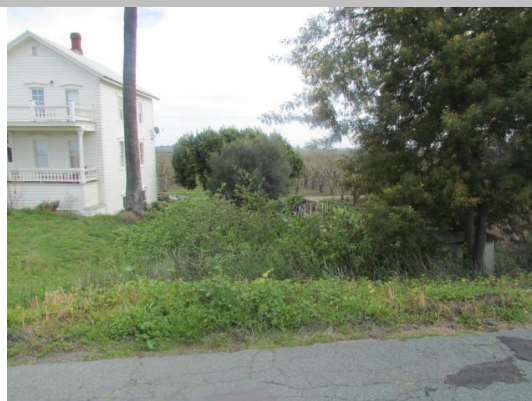
Photo 2 of 2 : FA\_2018\_RD0003\_24\_8\_20180925\_00008.jpg

LM Start	1.76	Rating **	M	Issue No.	8 (cont)	
LM End	1.76	Issue Type +	En	Location *	LS	
Category	Earthen Levee			GPS Latitude/Longitude		
				Start		End
Item	Vegetation			38.282771 °		38.282771 °
				-121.588227 °		-121.588227 °
DWR ID	DWR_RD0003_01_s_2012_8					
Comment Code						
V6 : Landscaping						
Inspector Comment

Looking east at vegetation on landside slope.

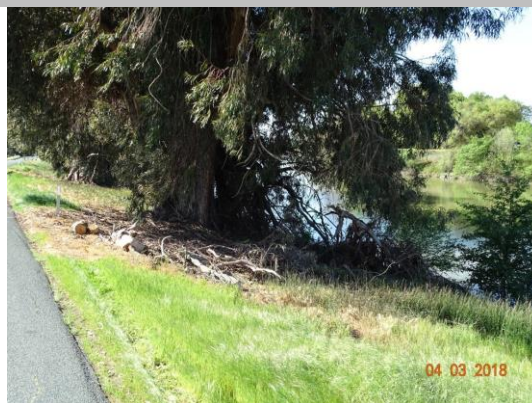
Photo 1 of 1 : FA\_2018\_RD0003\_24\_54\_20180925\_00039.jpg

LM Start	1.91	Rating **	M	Issue No.	54
LM End	1.91	Issue Type +	Ma	Location *	WS
Category	Earthen Levee			GPS Latitude/Longitude	
				Start	End
Item	Encroachments			38.280638 °	38.280638 °
				-121.588457 °	-121.588457 °
DWR ID	DWR_RD0003_01_s_2018_54				
Comment Code					
TR : Tree or limb					
Inspector Comment					
Remove tree trimmings.

Cut branches on waterside slope.

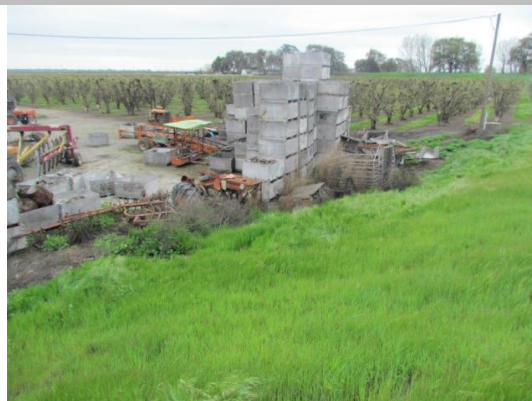
Photo 1 of 1 : FA\_2018\_RD0003\_24\_70\_20180925\_00054.jpg

LM Start	2.11	Rating **	M	Issue No.	70
LM End	2.11	Issue Type +	En	Location *	LS
Category	Earthen Levee			GPS Latitude/Longitude	
				Start	End
Item	Encroachments			38.277908 °	38.277908 °
				-121.589138 °	-121.589138 °
DWR ID	DWR_RD0003_01_s_2016_70				
Comment Code					
GA : Garbage					
Inspector Comment					
Old farm equipment and storage containers stored at landward toe.

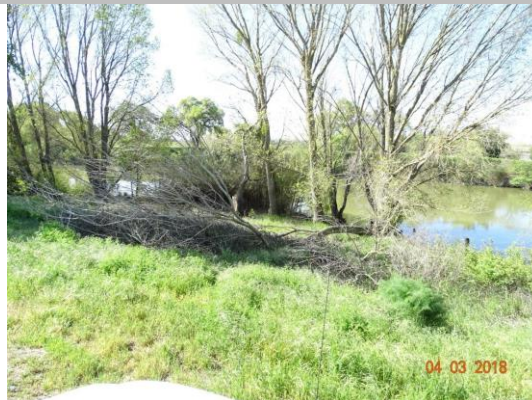
Photo 1 of 1 : FA\_2018\_RD0003\_24\_55\_20180925\_00040.jpg

LM Start	2.27	Rating **	M	Issue No.	55
LM End	2.27	Issue Type +	Ma	Location *	WS
Category	Earthen Levee			GPS Latitude/Longitude	
				Start	End
Item	Encroachments			38.275827 °	38.275827 °
				-121.589979 °	-121.589979 °
DWR ID	DWR_RD0003_01_s_2018_55				
Comment Code					
TR : Tree or limb					
Inspector Comment					
Fallen tree on waterside slope.

Fallen tree limb on waterside.

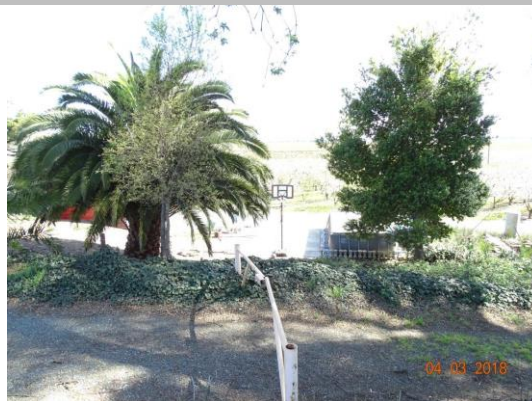
Photo 1 of 1 : FA\_2018\_RD0003\_24\_26\_20180925\_00025.jpg

LM Start	2.38	Rating **	M	Issue No.	26
LM End	2.38	Issue Type +	En	Location *	LS
Category	Earthen Levee			GPS Latitude/Longitude	
				Start	End
Item	Vegetation			38.274775 °	38.274775 °
				-121.588295 °	-121.588295 °
DWR ID	DWR_RD0003_01_s_2013_26				
Comment Code					
V6 : Landscaping					
Inspector Comment					
Landscaping has been reduced in this area, but still inhibits inspection and access.

Landscaping should continue to be reduced.

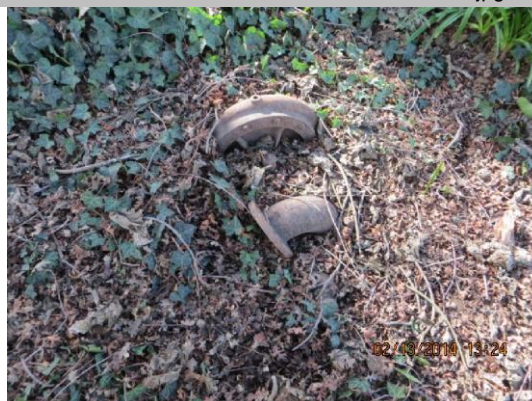
Photo 1 of 3 : UCIP\_FA\_2018\_29569\_54641.jpg

Comment Code						
Inspector Comment						
FS_ID:29569						
DS_ID:22324						
EP_NO: 4346						
Repair Type: Non-Urgent						
Crossing Status: Indicator Found						
UCIP Comments: Pipe is abandoned and should be verified as having been done so properly.						
FIELD_STRUCT_DESC: 6-inch steel irrigation discharge pipe through the levee, invert elevation 1.5 feet below the crown. Pump visible at the landside (LS) toe. (Plans for replacing existing 10-inch pipe with a new 10-inch pipe through the levee authorized under Permit No. 4346, 1963 - Hamatani Brothers). [Additional Reference(s): USACE Sacramento O&M Manual 104, February 1960, (RM 23.70)].						
FS Date: 2/13/2014

Pump visible on LS toe.

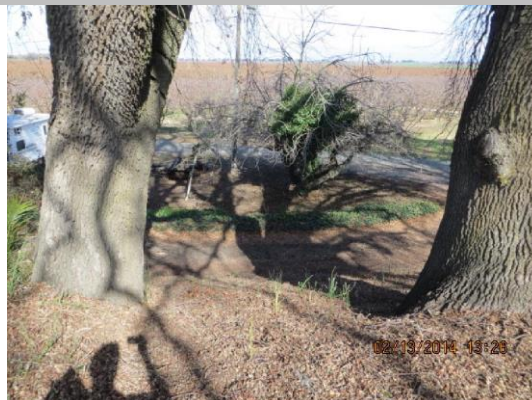
Photo 2 of 3 : UCIP\_FA\_2018\_29569\_54640.jpg

Pump visible at LS toe. Pipe alignment of old pipe goes between two large oaks on LS shoulder.

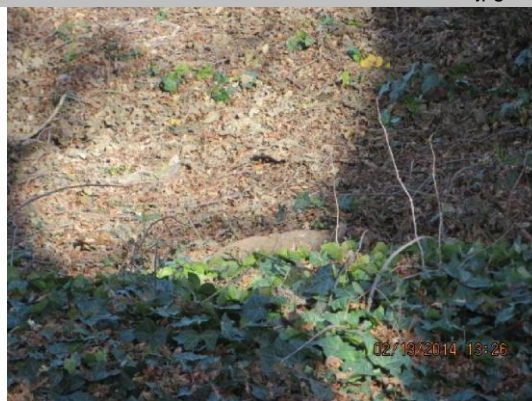
Photo 3 of 3 : UCIP\_FA\_2018\_29569\_54639.jpg

Comment Code						
Inspector Comment						
FS_ID:29569						
DS_ID:22324						
EP_NO: 4346						
Repair Type: Non-Urgent						
Crossing Status: Indicator Found						
UCIP Comments: Pipe is abandoned and should be verified as having been done so properly.						
FIELD_STRUCT_DESC: 6-inch steel irrigation discharge pipe through the levee, invert elevation 1.5 feet below the crown. Pump visible at the landside (LS) toe. (Plans for replacing existing 10-inch pipe with a new 10-inch pipe through the levee authorized under Permit No. 4346, 1963 - Hamatani Brothers). [Additional Reference(s): USACE Sacramento O&M Manual 104, February 1960, (RM 23.70)].						
FS Date: 2/13/2014

Pump visible on LS toe.

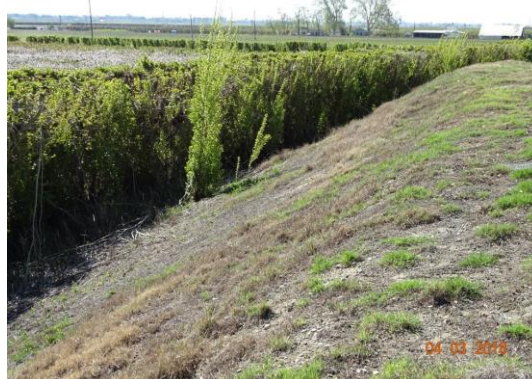
Photo 1 of 1 : FA\_2018\_RD0003\_24\_57\_20180925\_00041.jpg

LM Start	2.43	Rating **	U	Issue No.	57
LM End	2.74	Issue Type +	En	Location *	LS
Category	Earthen Levee			GPS Latitude/Longitude	
				Start	End
Item	Encroachments			38.274213 °	38.269914 °
				-121.587646 °	-121.588682 °
DWR ID	DWR_RD0003_01_s_2018_57				
Comment Code					
TR : Tree or limb					
Inspector Comment					
Row of trees along toe of levee inhibits inspection and prevents access.

Closely spaced trees along toe.

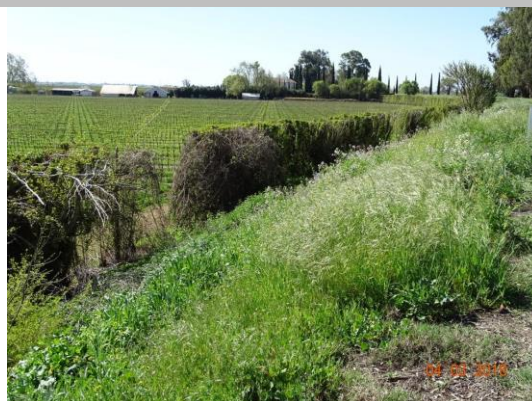
Photo 1 of 1 : FA\_2018\_RD0003\_24\_65\_20180925\_00050.jpg

LM Start	2.53	Rating **	U	Issue No.	65
LM End	2.57	Issue Type +	Ma	Location *	LS
Category	Earthen Levee			GPS Latitude/Longitude	
				Start	End
Item	Vegetation			38.272886 °	38.272262 °
				-121.587624 °	-121.588010 °
DWR ID	DWR_RD0003_01_s_2018_65				
Comment Code					
V1 : Control annual grass and weeds on the levee slopes and easements.					
Inspector Comment

Landside vegetation.

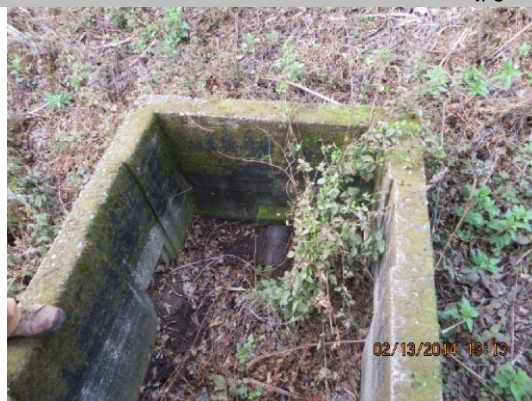
Photo 2 of 2 : UCIP\_FA\_2018\_29567\_54633.jpg

LM Start	2.55	Rating **	M	Issue No.	192 (cont)	
LM End	2.55	Issue Type +	En	Location *		
Category	Supplemental			GPS Latitude/Longitude		
				Start	End	
Item	DWR UCIP Field Study			38.272613 °	38.272613 °	
				-121.587821 °	-121.587821 °	
DWR ID	22146					
Comment Code						
Inspector Comment						
FS_ID:29567 DS_ID:22146 EP_NO: N/A Repair Type: Non-Urgent Crossing Status: Found UCIP Comments: Need to verify proper abandonment of irrigation pipe. FIELD_STRUCT_DESC: *ABANDONED* 10-inch steel irrigation discharge pipe through the levee, invert elevation 4.2 feet below the crown. 5-foot by 7-foot concrete distribution box at the landside (LS) toe. Cannot see pipe on the waterside (WS). [Additional Reference(s): DWR Levee Log, 1993. USACE Sacramento O&M Manual 104, February 1960, (RM 23.55)]. FS Date: 2/13/2014

Pipe visible inside concrete distribution box on LS toe.

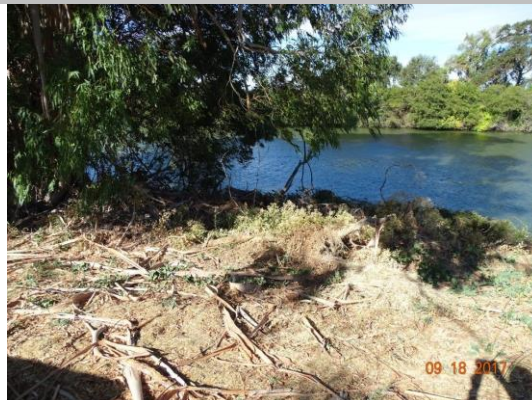
Photo 1 of 1 : FA\_2018\_RD0003\_24\_82\_20180925\_00070.jpg

LM Start	2.66	Rating **	M	Issue No.	82
LM End	2.66	Issue Type +	Ma	Location *	WS
Category	Earthen Levee			GPS Latitude/Longitude	
				Start	End
Item	Encroachments			38.271128 °	38.271128 °
				-121.588634 °	-121.588634 °
DWR ID	DWR_RD0003_01_f_2017_82				
Comment Code					
TR : Tree or limb					
Inspector Comment					
Tree limbs should be removed water side slope.

Looking southwest at waterside slope.

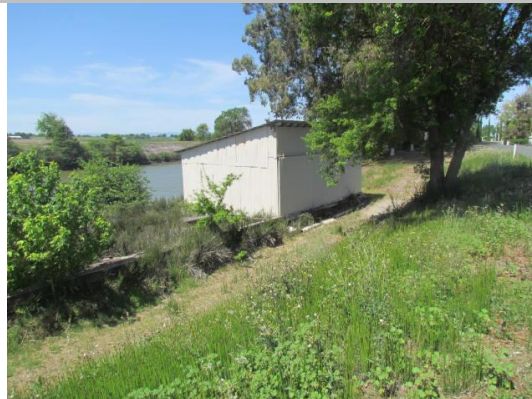
Photo 1 of 1 : FA\_2018\_RD0003\_24\_48\_20180925\_00031.jpg

LM Start	2.87	Rating **	U	Issue No.	48
LM End	2.87	Issue Type +	En	Location *	WS
Category	Earthen Levee			GPS Latitude/Longitude	
				Start	End
Item	Encroachments			38.268257 °	38.268257 °
				-121.587677 °	-121.587677 °
DWR ID	DWR_RD0003_01_s _ 2013_48				
Comment Code					
BU : Building					
Inspector Comment					
Storage shed has been here for several years on waterward berm. Storage shed appears to be abandoned and should be removed.

Looking northwest at storage shed on waterward berm.

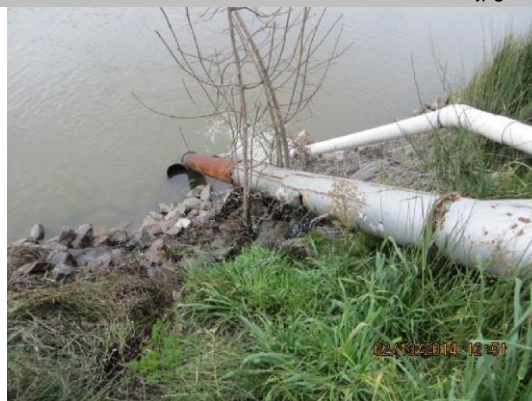
Photo 1 of 3 : UCIP\_FA\_2018\_29563\_54622.jpg

Comment Code						
Inspector Comment						
FS_ID:29563 DS_ID:22148 EP_NO: N/A Repair Type: Non-Urgent Crossing Status: Found UCIP Comments: Pitted holes on slant pump intake may indicate internal problem. Good candidate for video inspection. FIELD_STRUCT_DESC: 14-inch steel irrigation discharge pipe though the levee, invert elevation 6.3 feet below the crown. Service pole on the landside (LS) slope. 1.5-inch electrical conduit through the levee to the pump on the waterside (WS). 36-inch concrete standpipe at the landside (LS) toe. [Additional Reference(s): DWR Levee Log, 1993, 16-inch pipe referenced. USACE Sacramento O&M Manual 104, February 1960, (RM 23.17), 16-inch pipe referenced]. FS Date: 2/13/2014

Intake pipe at slantpump on WS slope.

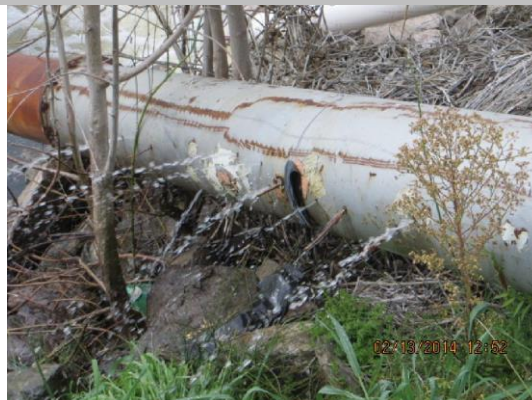
Photo 2 of 3 : UCIP\_FA\_2018\_29563\_54621.jpg

Multiple leaks in suction pipe on WS slope.

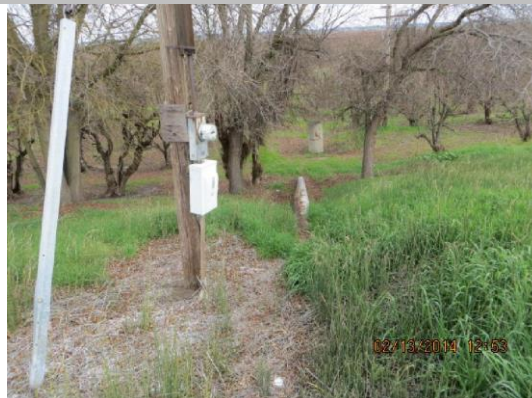
Photo 3 of 3 : UCIP\_FA\_2018\_29563\_54620.jpg

Comment Code						
Inspector Comment						
FS_ID:29563 DS_ID:22148 EP_NO: N/A Repair Type: Non-Urgent Crossing Status: Found UCIP Comments: Pitted holes on slant pump intake may indicate internal problem. Good candidate for video inspection. FIELD_STRUCT_DESC: 14-inch steel irrigation discharge pipe though the levee, invert elevation 6.3 feet below the crown. Service pole on the landside (LS) slope. 1.5-inch electrical conduit through the levee to the pump on the waterside (WS). 36-inch concrete standpipe at the landside (LS) toe. [Additional Reference(s): DWR Levee Log, 1993, 16-inch pipe referenced. USACE Sacramento O&M Manual 104, February 1960, (RM 23.17), 16-inch pipe referenced]. FS Date: 2/13/2014

Pipe and standpipe visible on LS toe. Power pole and meter on LS slope.

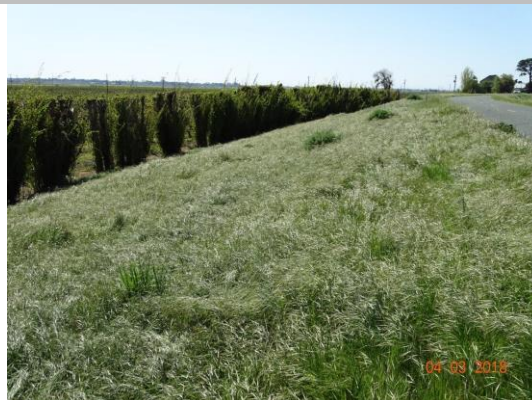
Photo 1 of 1 : FA\_2018\_RD0003\_24\_68\_20180925\_00052.jpg

LM Start	2.93	Rating **	U	Issue No.	68
LM End	3.06	Issue Type +	En	Location *	LS
Category	Earthen Levee			GPS Latitude/Longitude	
				Start	End
Item	Encroachments			38.267448 °	38.265504 °
				-121.587369 °	-121.587155 °
DWR ID	DWR_RD0003_01_s_2018_68				
Comment Code					
TR : Tree or limb					
Inspector Comment					
Row of trees along landside toe inhibits inspection and prevents access.

Closely spaced trees along toe (Spring 2018).

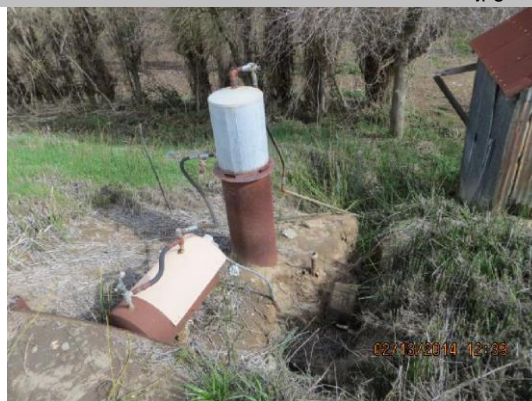
Photo 1 of 2 : UCIP\_FA\_2018\_31327\_57380.jpg

Comment Code						
Inspector Comment						
FS_ID:31327 DS_ID:22149 EP_NO: 6870 Repair Type: Non-Urgent Crossing Status: Found UCIP Comments: Erosion on LS slope between pumphouse and tank. FIELD_STRUCT_DESC: 1 of 3: 18-inch steel irrigation discharge pipe through the levee, invert elevation 5.5 feet below the crown. Primer pump in a pump house on the landside (LS) slope. Tank and filler pipes on the LS slope. (Plans to retain a pump house, a pressure tank, two buried metal tanks, and a pipeline authorized under Permit No. 6870, 1970 - H. P. Garin Jr, et al.). [Additional Reference(s): DWR Levee Log, 1993. USACE Sacramento O&M Manual 104, February 1960, (RM 23.03)]. FS Date: 2/13/2014

Pumphouse , tank, and filler pipes visible on LS slope. (note erosion between tank and pumphouse).

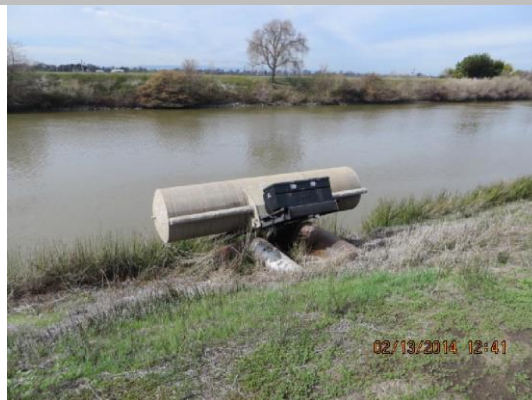
Photo 2 of 2 : UCIP\_FA\_2018\_31327\_57379.jpg

Pipe with fish screen visible on WS slope.

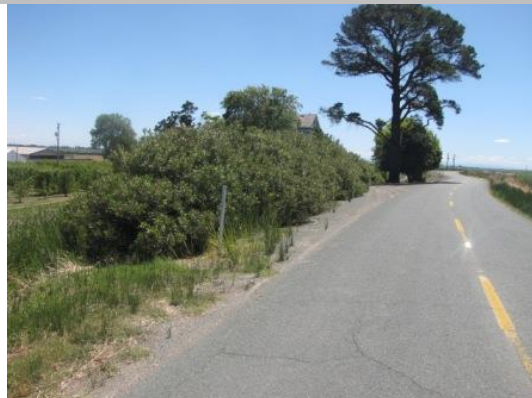
Photo 1 of 1 : FA\_2018\_RD0003\_24\_20\_20180925\_00021.jpg

LM Start	3.11	Rating **	U	Issue No.	20
LM End	3.13	Issue Type +	En	Location *	LS
Category	Earthen Levee			GPS Latitude/Longitude	
				Start	End
Item	Vegetation			38.264902°	38.264580°
				-121.587193°	-121.587220°
DWR ID	DWR_RD0003_01_s_2012_20				
Comment Code					
V6 : Landscaping					
Inspector Comment					
Oleander on landside shoulder.

Looking south at dense veg. on landside slope.

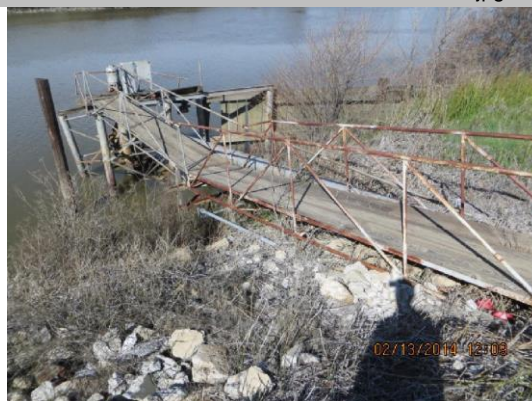
Photo 1 of 3 : UCIP\_FA\_2018\_29547\_54611.jpg

Comment Code						
Inspector Comment						
FS_ID:29547						
DS_ID:22151						
EP_NO: 1113						
Repair Type: Non-Urgent						
Crossing Status: Found						
UCIP Comments: Pump pier is damaged and falling into the water.						
FIELD_STRUCT_DESC: 12-inch steel irrigation discharge pipe through the levee, invert elevation 4 feet below the crown. Vertical pump on a pile structure in the stream. Walkway from the waterside (WS) berm to the pump. 1.5-inch electrical conduit and 2.5-inch filler pipe at the same location. 36-inch concrete standpipe on the landside (LS) toe. (Plans for the installation of a 12-inch irrigation pipe through the levee authorized under Permit No. 1113, 1946 - Elsie Goldman Dixon). [Additional Reference(s): DWR Levee Log, 1993. USACE Sacramento O&M Manual 104, February 1960, (RM 22.85)].						
FS Date: 2/13/2014

Walkway to pump on pier at WS slope.

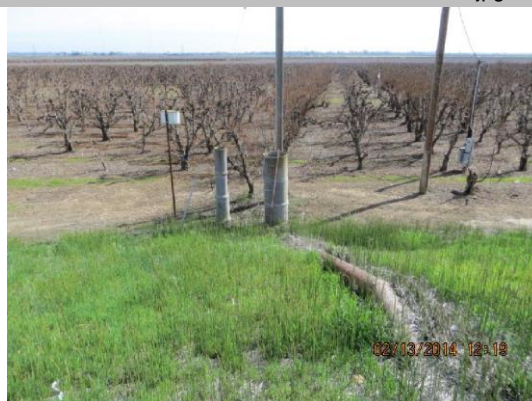
Photo 3 of 3 : UCIP\_FA\_2018\_29547\_54609.jpg

Comment Code						
Inspector Comment						
FS_ID:29547 DS_ID:22151 EP_NO: 1113 Repair Type: Non-Urgent Crossing Status: Found UCIP Comments: Pump pier is damaged and falling into the water. FIELD_STRUCT_DESC: 12-inch steel irrigation discharge pipe through the levee, invert elevation 4 feet below the crown. Vertical pump on a pile structure in the stream. Walkway from the waterside (WS) berm to the pump. 1.5-inch electrical conduit and 2.5-inch filler pipe at the same location. 36-inch concrete standpipe on the landside (LS) toe. (Plans for the installation of a 12-inch irrigation pipe through the levee authorized under Permit No. 1113, 1946 - Elsie Goldman Dixon). [Additional Reference(s): DWR Levee Log, 1993. USACE Sacramento O&M Manual 104, February 1960, (RM 22.85)]. FS Date: 2/13/2014

Concrete standpipe and pipe visible on LS toe.

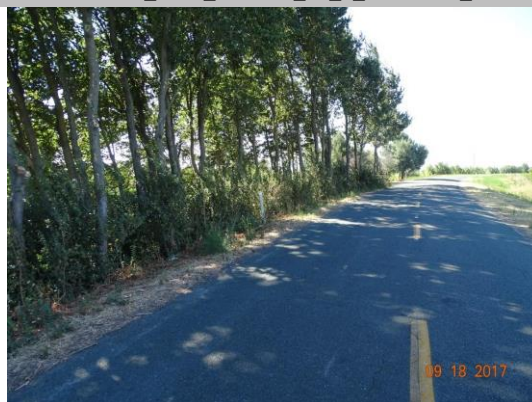
Photo 1 of 3 : FA\_2018\_RD0003\_24\_9\_20180925\_00009.jpg

LM Start	3.82	Rating **	U	Issue No.	9
LM End	3.87	Issue Type +	En	Location *	LS
Category	Earthen Levee			GPS Latitude/Longitude	
				Start	End
Item	Vegetation			38.258222 °	38.257453 °
				-121.593793 °	-121.593942 °
DWR ID	DWR_RD0003_01_s_2012_9				
Comment Code					
V6 : Landscaping					
Inspector Comment

Looking south at landside slope.

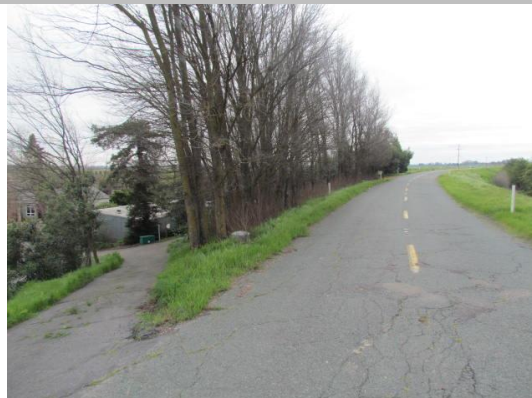
Photo 2 of 3 : FA\_2018\_RD0003\_24\_9\_20180925\_00010.jpg

LM Start	3.82	Rating **	U	Issue No.	9 (cont)	
LM End	3.87	Issue Type +	En	Location *	LS	
Category	Earthen Levee			GPS Latitude/Longitude		
				Start	End	
Item	Vegetation			38.258222°	38.257453°	
				-121.593793°	-121.593942°	
DWR ID	DWR_RD0003_01_s_2012_9					
Comment Code						
V6 : Landscaping						
Inspector Comment

Looking south at trees on landward shoulder and slope (Spring 2016).

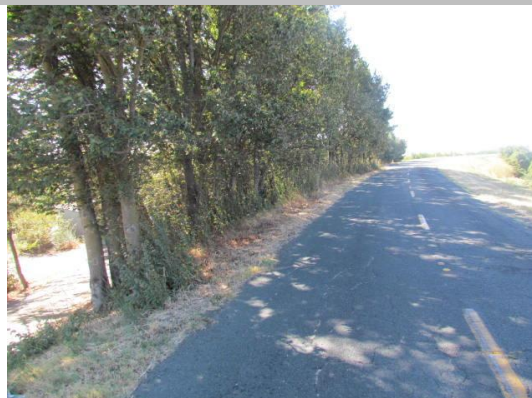
Photo 3 of 3 : FA\_2018\_RD0003\_24\_9\_20180925\_00011.jpg

Looking south at trees on landward shoulder and slope. (Fall 2015)

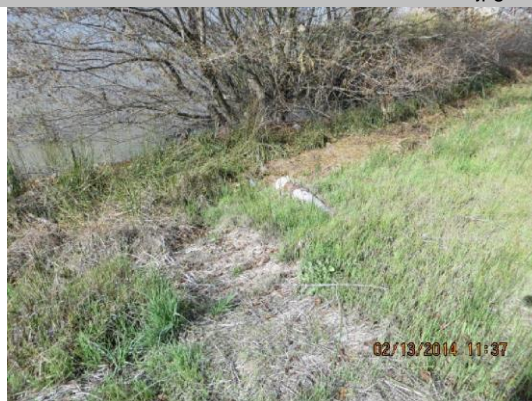
Photo 1 of 3 : UCIP\_FA\_2018\_29530\_54592.jpg

Comment Code						
Inspector Comment						
FS_ID:29530 DS_ID:22317 EP_NO: 17221 Repair Type: Non-Urgent Crossing Status: Found UCIP Comments: Open trench along WS slope parallell to river. FIELD_STRUCT_DESC: 7-inch steel boat dock service conduit through the levee, 4 feet below the crown. 1.5-inch and 4-inch polyvinyl chloride (PVC) pipes sleeved through the 7-inch conduit. Steps on the waterside (WS) slope. Tank on the landside (LS) shoulder. Conduit provides service to the boat dock just upstream. (Plans to install 1.5-inch and 4-inch PVC pipes through the existing 8-inch steel pipe and through the LS slope, to construct a 48-foot by 21-foot boat dock supported on four steel piles, and to construct a 14-foot-wide access ramp on the LS slope authorized under Permit No. 17221, 2000 - Hart, Inc). FS Date: 2/13/2014

7-inch pipe visible on WS slope.

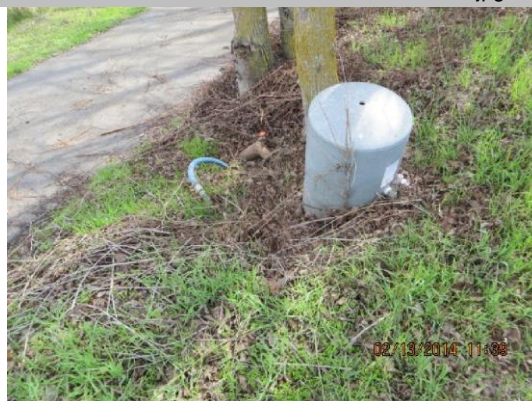
Photo 3 of 3 : UCIP\_FA\_2018\_29530\_54590.jpg

Comment Code						
Inspector Comment						
FS_ID:29530 DS_ID:22317 EP_NO: 17221 Repair Type: Non-Urgent Crossing Status: Found UCIP Comments: Open trench along WS slope parallell to river. FIELD_STRUCT_DESC: 7-inch steel boat dock service conduit through the levee, 4 feet below the crown. 1.5-inch and 4-inch polyvinyl chloride (PVC) pipes sleeved through the 7-inch conduit. Steps on the waterside (WS) slope. Tank on the landside (LS) shoulder. Conduit provides service to the boat dock just upstream. (Plans to install 1.5-inch and 4-inch PVC pipes through the existing 8-inch steel pipe and through the LS slope, to construct a 48-foot by 21-foot boat dock supported on four steel piles, and to construct a 14-foot-wide access ramp on the LS slope authorized under Permit No. 17221, 2000 - Hart, Inc). FS Date: 2/13/2014

Tank on LS shoulder.

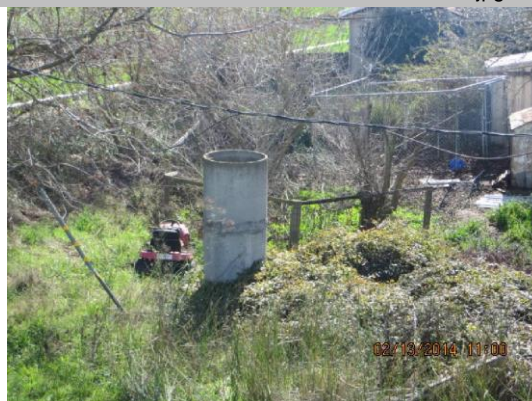
Photo 1 of 2 : UCIP\_FA\_2018\_31583\_57841.jpg

Comment Code						
Inspector Comment						
FS_ID:31583 DS_ID:22160 EP_NO: 7948 Repair Type: Non-Urgent Crossing Status: Found UCIP Comments: Siphon breaker missing from LS shoulder. FIELD_STRUCT_DESC: 14-inch coated steel irrigation discharge pipe through the levee, 4.5 feet below the crown. Pipe measures 12 inches on the slopes. Slant pump and platform on the waterside (WS) slope. Siphon breaker on the landside (LS) shoulder. 36-inch concrete standpipe off the LS toe. 1.5-inch galvanized iron electrical conduit at the same location. (Plans to replace pump and pipe through the levee authorized under Permit No. 7948, 1972 - Carl E. van Loben Sels). [Additional Reference(s): DWR Levee Log, 1993. USACE Sacramento O&M Manual 104, February 1960, (RM 21.97), referenced as invert elevation 4.2 feet below the crown]. FS Date: 2/13/2014

36-inch concrete standpipe off LS toe.

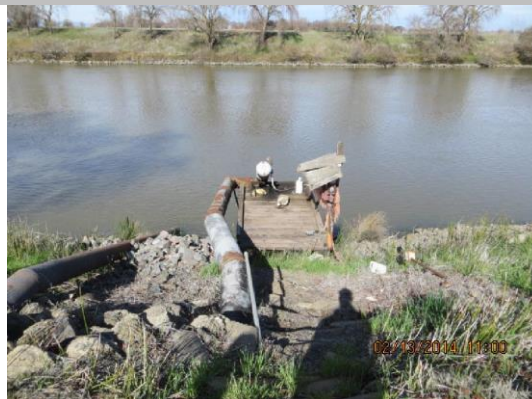
Photo 2 of 2 : UCIP\_FA\_2018\_31583\_57840.jpg

Pipe visible on WS slope with pump on pier and electrical conduit.

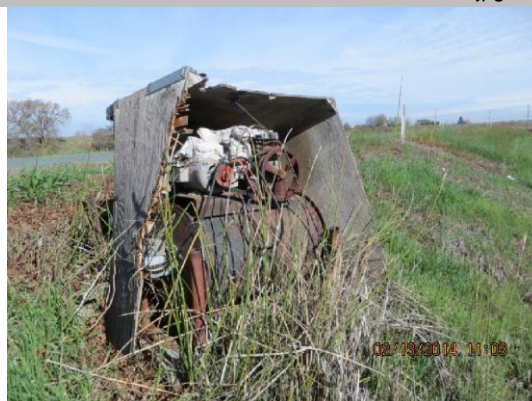
Photo 1 of 3 : UCIP\_FA\_2018\_31584\_57843.jpg

LM Start	4.11	Rating **	M	Issue No.	198
LM End	4.11	Issue Type +	En	Location *	
Category	Supplemental			GPS Latitude/Longitude	
				Start	End
Item	DWR UCIP Field Study			38.254596 °	38.254596 °
				-121.596392 °	-121.596392 °
DWR ID	22158				
Comment Code					
Inspector Comment					
FS_ID:31584 DS_ID:22158 EP_NO: N/A Repair Type: Non-Urgent Crossing Status: Found UCIP Comments: Appears abandoned and if so should be done so properly. FIELD_STRUCT_DESC: 12-inch steel irrigation siphon through the levee, invert elevation 2.7 feet below the crown. Pump and tank visible in a box on the landside (LS) shoulder. Electrical panel on the LS slope with a concrete standpipe at the LS toe. [Additional Reference(s): USACE Sacramento O&M Manual 104, February 1960, (RM 21.97), 10-inch pipe referenced]. FS Date: 2/13/2014

Pump and tank in box on LS shoulder.

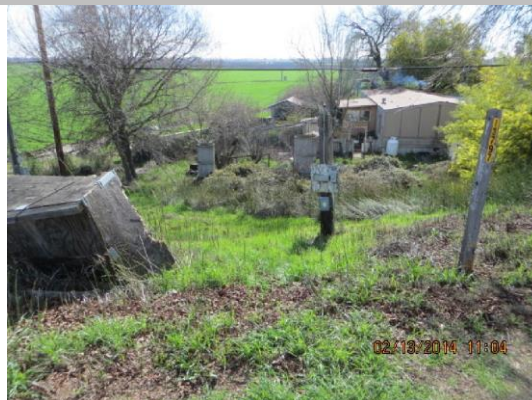
Photo 2 of 3 : UCIP\_FA\_2018\_31584\_57842.jpg

Pump and tank in box on LS shoulder with concrete standpipe visible on LS toe.

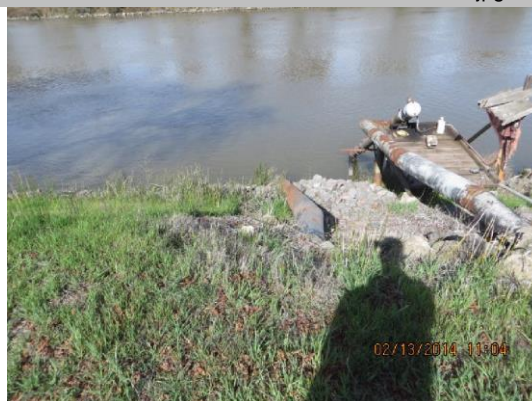
Photo 3 of 3 : UCIP\_FA\_2018\_31584\_57844.jpg

LM Start	4.11	Rating **	M	Issue No.	198 (cont)	
LM End	4.11	Issue Type +	En	Location *		
Category	Supplemental			GPS Latitude/Longitude		
				Start	End	
Item	DWR UCIP Field Study			38.254596 °	38.254596 °	
				-121.596392 °	-121.596392 °	
DWR ID	22158					
Comment Code						
Inspector Comment						
FS_ID:31584 DS_ID:22158 EP_NO: N/A Repair Type: Non-Urgent Crossing Status: Found UCIP Comments: Appears abandoned and if so should be done so properly. FIELD_STRUCT_DESC: 12-inch steel irrigation siphon through the levee, invert elevation 2.7 feet below the crown. Pump and tank visible in a box on the landside (LS) shoulder. Electrical panel on the LS slope with a concrete standpipe at the LS toe. [Additional Reference(s): USACE Sacramento O&M Manual 104, February 1960, (RM 21.97), 10-inch pipe referenced]. FS Date: 2/13/2014

Pipe visible on WS slope.

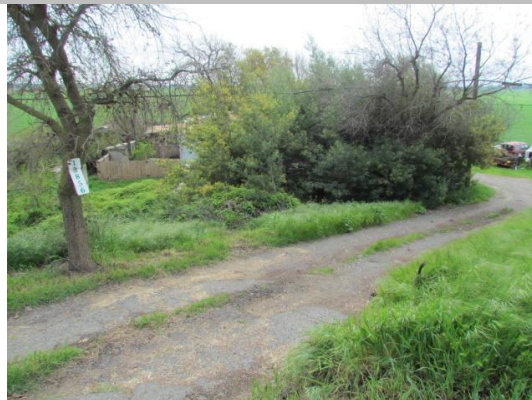
Photo 1 of 1 : FA\_2018\_RD0003\_24\_71\_20180925\_00055.jpg

LM Start	4.12	Rating **	U	Issue No.	71
LM End	4.12	Issue Type +	En	Location *	LS
Category	Earthen Levee			GPS Latitude/Longitude	
				Start	End
Item	Vegetation			38.254565 °	38.254565 °
				-121.596437 °	-121.596437 °
DWR ID	DWR_RD0003_01_f_2017_71				
Comment Code					
V6 : Landscaping					
Inspector Comment					
Dense trees blocking view of landward toe.

Looking east at dense vegetatin next to ramp on landward slope.

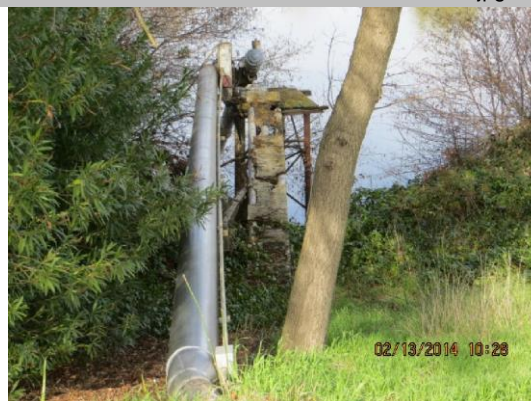
Photo 1 of 3 : UCIP\_FA\_2018\_53483\_54546.jpg

UCIP Comments: 07/20/2018 Everything appears to be the same as last time. No changes have been made. Most of the pipe still remains. Did not see any active leakage. Tape was wrapped around the pipe connections on the LS in 2016 to prevent leaking. Crossing remains "Urgent" due to the pipe integrity issues that have not been fully addressed. (DWR UCIP - A. McDonald)09/29/2017 Received updated photo from DWR levee inspector, D. Torres, and photo shows part or all of the pipe has been removed. Inspector could not verify proper abandonment. Need to coordinate with LMA and owner to determine supporting documentation to support the work completed at this site. This crossing remains urgent due to the details of the extent of the removal. No permit was found to authorizing levee work. (DWR UCIP - O. Magana) 07/06/2016 Pipe diversion off main steam on LS has tape wrapped around its connections, a possible attempt to contain past leakage. Did not see active leakage. Slight sloughing on LS slope at diversion manifold. (DWR UCIP - kfazel)02/13/2014 Pipe disconnected or diverted on LS shoulder and leaking. Water runs down LS slope freely causing erosion. Siphon breaker not visible in CMP riser. Walkway to pump in poor structural condition. (DWR UCIP - pamatya)

Pipe visible on WS slope with slantpump on pier.
